Research on China's the Oldest Wooden Building Structure in the Tang Dynasty-the Restoration Model of the Main Hall of Nanchan Temple, Re-Understanding the Value of Heritage

Songfeng Jing^{*1}, Hidekazu Nishizawa²

1. Graduate School of Science and Engineering, Kansai University, Osaka 564-8680, Japan

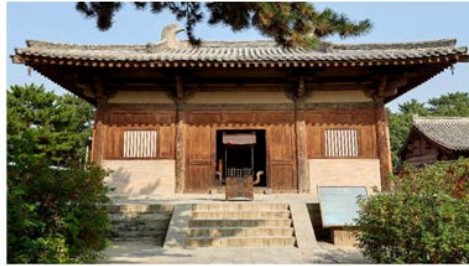
Fig.1 A photo of the front facade of the Main Hall of Nanchan Temple

This photo was taken after restoration in 1975, and the style of doors and windows at this time was completely different from before. (The picture from Baidu).

The Main Hall of Nanchan Temple was overhauled in 1974, the length of the Nanchan Temple rafters and the style of doors and windows were changed: the arch voucher became a rectangle; the dwarf pillars on the flat beams were also removed.

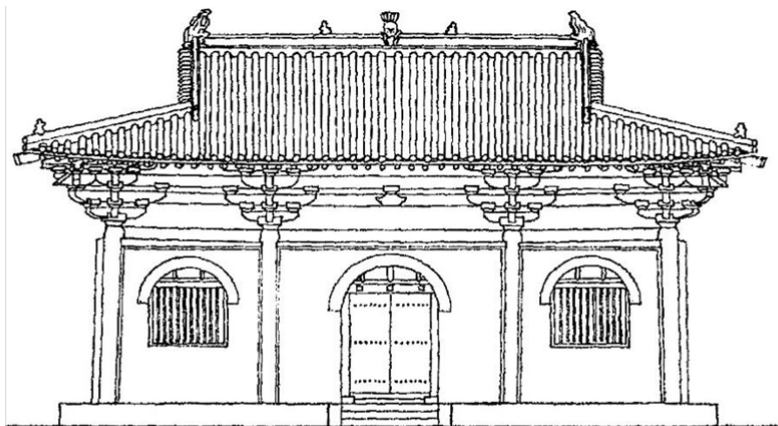
There are no pillars in the Main Hall of Nanchan Temple, and no ceiling is completely exposed. The two long four-rafters are horizontally framed on the front and rear eaves columns, and the stilts are turned on the back to reach the front and rear eaves. Then they are Tuo Feng, Dado, Ling Gong, Cheng Ping Beam. The two ends of the flat beam support the Zhu Jiao, on which the spine is

supported by the large crossed hands, without Tuofeng and ZhuRu-Column. This structure is an ancient system during the Han and Tang Dynasties, and has disappeared after the Five Dynasties. (Figure2)

Fig.2 The Elevation of the Main Hall of Nanchan Temple Before Restoration. the Picture from Ito Nobuo, Sawamura Ni, Sekiguchi Kinya²(1969).

It can be seen from Fig.2 and Fig.4 that the rafters on the roof of the Main Hall of Nanchan Temple are longer than before the restoration.

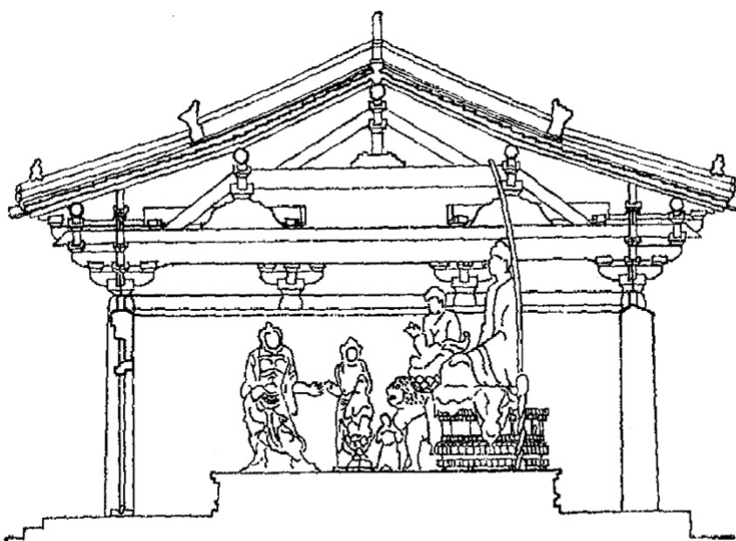
Fig.3 The Section View of the Main Hall of Nanchan Temple Before Restoration. the Picture from Ito Nobuo, Sawamura Ni, Sekiguchi Kinya²(1969).

Ding Fu is used for the two mountains of the beam and the frame, and only a tie is set at the corner to support the intersection point of the rafter and the flat, supported by the Zhi Dou, The Liang Fu style are all Yue-Liang. The eaves pillars support the eaves, and there is no intervening paving, and the ancient system still exists. The Zhu Tou is made of five Pu-Zuo that is the Shuangchao Dougong Touxin Zao. In the second Tiao, the Hua Gong is made by stretching out the four rafters outside the eaves. The backs are stretched out under the eaves and chopped to make

Shua Tou. They are used to replace the wooden and eaves with the Ling Gong (Figure 3).

From the comparison of Fig.3 and Fig. 5, it can be seen that Zhu-Ru column above the Ping-Liang is different. It was removed when it was restored in 1975. The author believes that the restoration at that time did not take into account the value and authenticity of the heritage, which is different from the current concept of heritage protection and appraisal.

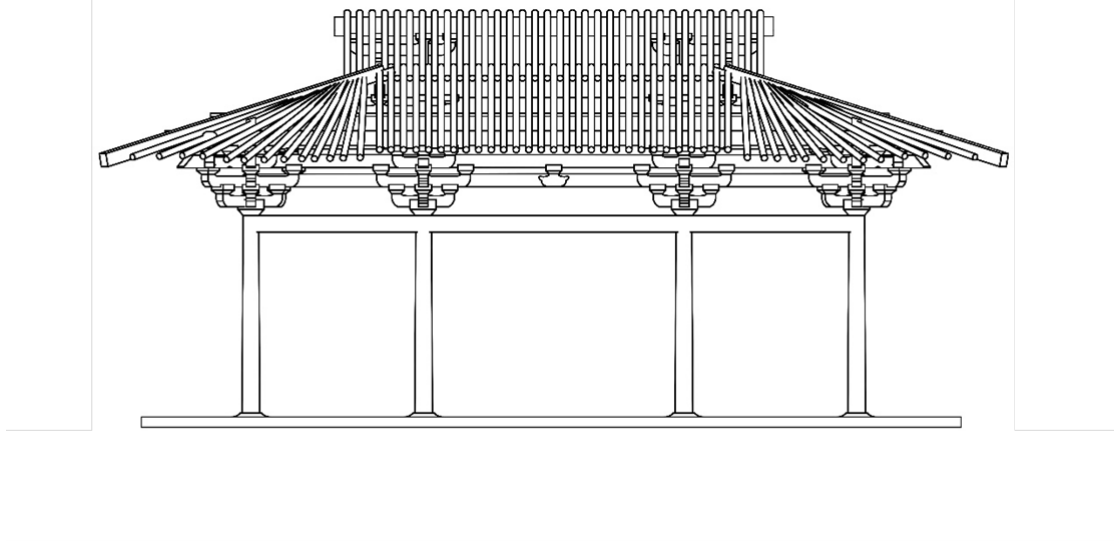
Fig.4 The Elevation of the Main Hall of Nanchan Temple after Restoration. (Picture Source, Drawn by the Author).

Qi Yingtao scholars believe that the Main Hall of Nanchan Temple belongs to the Tang Dynasty, and the length of the rafters can just cover the part of the foundation, and will not be wet by the rain. Further inference: each dynasty saw it cut off during repairs. So, it was restored in 1975 when it was restored. That is the status quo now.

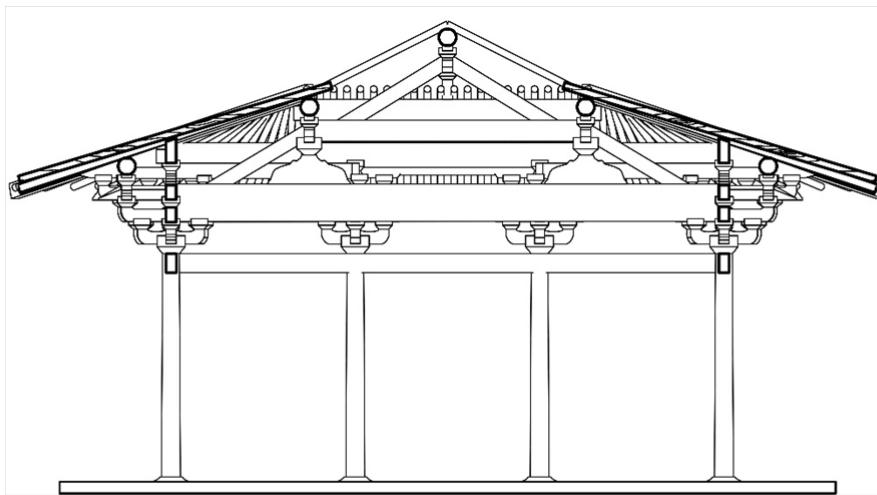
Fig.5 The section view of the Main Hall of Nanchan Temple after restoration. (Picture source, drawn by the author).

Fig.5 The Section View of the Main Hall of Nanchan Temple after Restoration. (Picture Source, Drawn by the Author).

The Dou Gong on both sides of the building is the outer end of Ding Fu. A 45-degree oblique angle is applied at the corner to make the angle into a Yuan-yang Ling Gong. Above the Zhu Tou is Ni-Dao Gong, the Zhu Tou is stacked on two layers, the lower layer is concealed with Ni-Dao Man Gong, the upper layer is set with a Tuo Feng, and Min Ban and San Dou are pressure-bearing troughs. Each scroll is divided into five petals, and each petal is slightly tilted inward. This style has been seen on the eaves of the grottoes in the Qi and Sui Dynasty and on the tomb sculptures. It is the only example in the real building. It can be seen from the picture that the shape of the early building is completely different from that in Figure 1. The length of the roof rafters and the style of doors and windows have all changed. However, in the early restoration, there are still insufficient

In combination with the restoration project of the Main Hall of Nanchan Temple in 1975, as can be seen from Figures 5 and 6, ZhuRu-Column on the Ping-Liang have been removed. The removal of the dwarf pillars and the changes in the style of doors and windows violated the most basic authenticity of the heritage. For the current heritage protection project, when there is no great certainty and technology, it is not easy to process the original state of the heritage⁸.

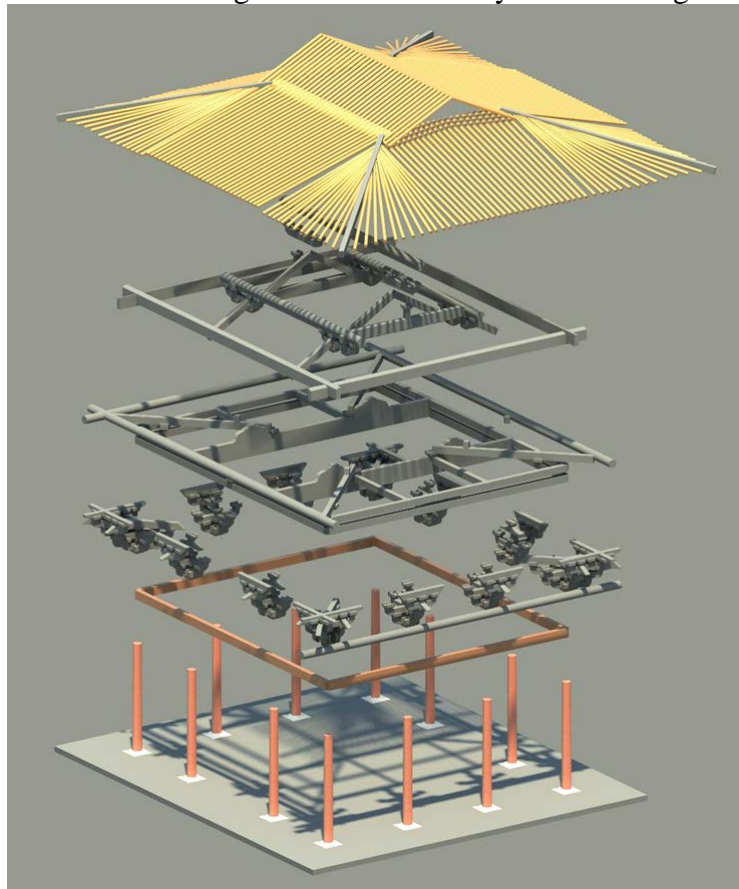
Fig.6 Disassembled 3d Model of the Main Hall of Nanchan Temple after Restoration. (Picture Source, Drawn by the Author).

The Main Hall of Nanchan Temple plane, substantially similar to a square, actually there are three columns square column, and the remaining 9 are circular pillars. According to the 1980 restoration report that three square columns are the most primitive state of construction. (Figure.6)

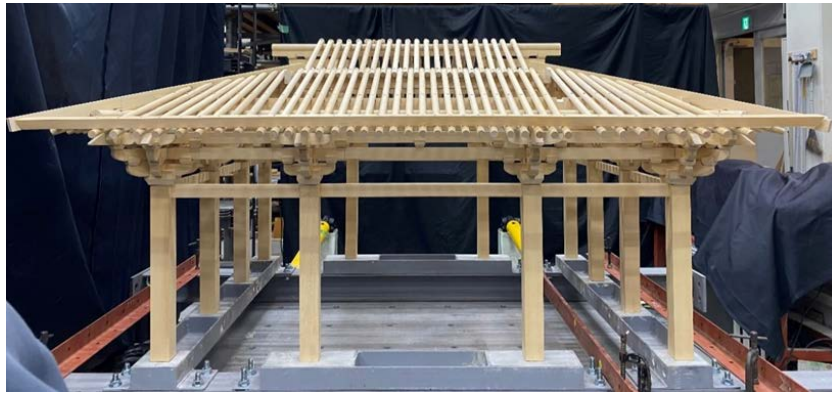
Fig.7 The Main Hall of Nanchan Temple Wooden Model Elevation. (Picture Source, Made by the Author).

In summary, this research systematically sorted out the literature of the Main Hall of Nanchan Temple. For the first time, the author have made a research drawing of Nanchan Temple Hall. To fully understand the construction process of the Main Hall of Nanchan Temple, and have made rendering drawings of 3D dismantling model; the model takes 8 months to complete, the collection of documents and materials through various channels. Completed the construction of 1/10 model. (Figure.7 and Figure.8).

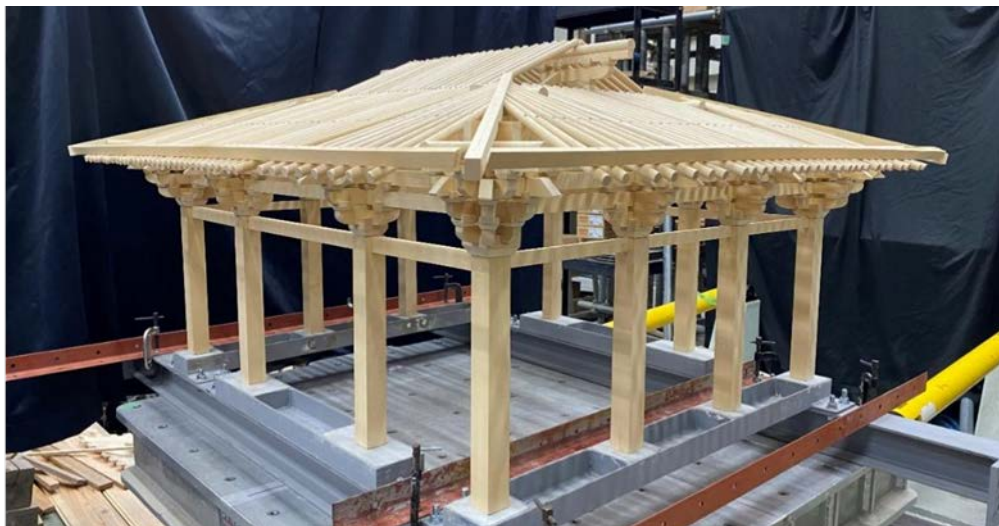
Fig.8 A Three-Dimensional Perspective View of the Main Hall of Nanchan Temple. (Picture Source, Made by the Author).
